## PRODUCT ADVISORY LETTER (PAL)

### PRODUCT ADVISORY LETTER NO.: CU46-19002

**AFFECTED PRODUCT(S):** UPLC-II

**AFFECTED MODULE(S):** Front Aux Display Card CU20-DP1A3-001 Rev. 3 or lower (on white label) that shipped before 4/8/2019. If labeled Rev 3, some boards still may not need the change as a long visible green wire jumper was added to the top of the board. We recommend trying to measure continuity (<2 ohms) between the front ethernet port metal shell and any screw on the metal chassis. If there is no continuity, then you need this upgrade, otherwise you don't.

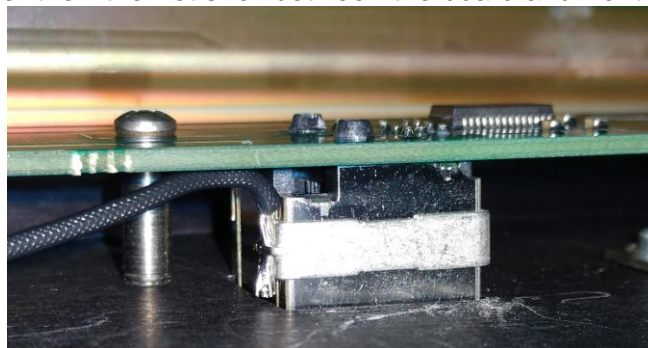
**SYMPTOM(s):** The front panel Ethernet metal shell is susceptible to Electrostatic Discharge (ESD). If enough static charge is applied the Display will reset and may show odd characters temporarily. Also, the four front LEDs may indicate incorrectly.

**TECHNICAL DETAILS:** The Ethernet metal shell is ungrounded. This allows ESD to travel from the Front Aux Display Card to the main Front Display card and cause a display reset. This reset only affects the display and the **TX RF ON** LED which in units set in the On/Off mode will erroneously illuminate without the unit transmitting. This LED will correctly reset to normal when the unit transmits.

- Ensure that the protection scheme using the UPLC/UPLC-II at the substation is locked out. \*
- Open the Front Door.
- Power off the UPLC-II by pulling the Power Supply card or other external method if available. \*
- Snap on the clip over the Ethernet shell between the board and front door.

*\* (If needed, the unit can be kept in service, and this can be done without powering down. Care should be exercised to prevent accidental shorts against the PC board with the jumper.)*
