PRODUCT ADVISORY LETTER (PAL)

PRODUCT ADVISORY LETTER NO.: CU46-19004

(UPLC/UPLC-II Display Module not displaying clearly)

AFFECTED PRODUCT(S): UPLC-II

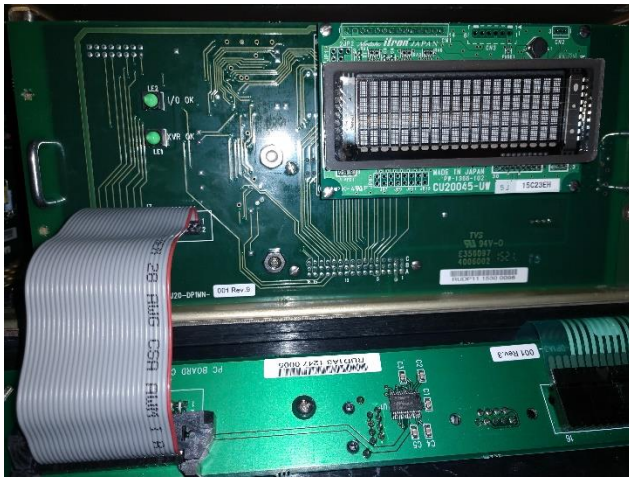
VFD Display Module

AFFECTED MODULE(S): Front Display Board CU20-DP1MN-001 Rev.11 (on white label) with OLED Display Module (shown below) that is displaying the symptoms below.

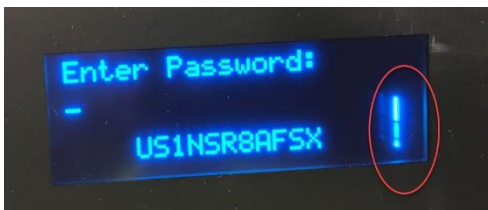
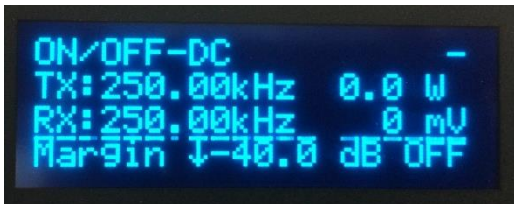
SYMPTOM(s): OLED Displays showing permanent horizontal or vertical lines or that are very dim. Pictures of some examples below:

TECHNICAL DETAILS: The Okaya OLED module was found to have failures due to manufacturing issues at the vendor. Steps were taken to screen these defective OLED modules at AMETEK, but it was found that failures could present themselves after our standard 3-day burn-in cycle done on all UPLC-II.

RECOMMENDATION: AMETEK recommends the corrective action listed below be taken for all UPLC-II with OLED displays with similar symptoms. This display issue **DOES NOT** affect the carrier functionality of the UPLC-II other than being able to read the front display.

CORRECTIVE ACTION: Call AMETEK Power Instruments Customer Services at **800-785-7274** to request an RMA for a Replacement Display Board with a later Rev OLED Display Module. This modification is available at no charge and will not affect any applicable warranty.
