## PRODUCT ADVISORY LETTER (PAL)

### PRODUCT ADVISORY LETTER NO.: CU46-19002

**AFFECTED PRODUCT(S):** UPLC-II

**AFFECTED MODULE(S):** Front Aux Display Card CU20-DP1A3-001 Rev. 3 or lower (on white label) that shipped before 4/8/2019. If labeled Rev 3, some boards still may not need the change as a long visible green wire jumper was added to the top of the board. We recommend trying to measure continuity (<2 ohms) between the front ethernet port metal shell and any screw on the metal chassis. If there is no continuity, then you need this upgrade, otherwise you don't.

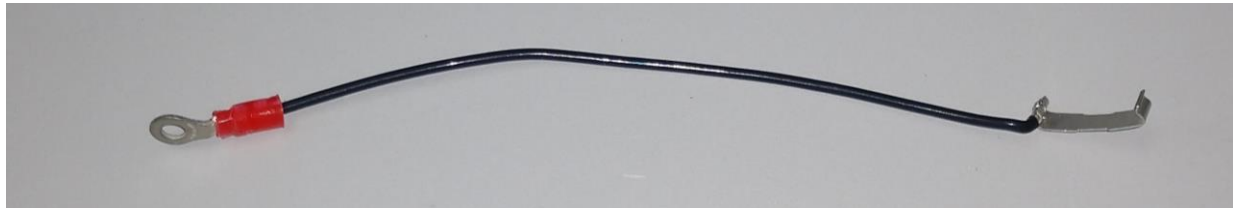
**SYMPTOM(s):** The front panel Ethernet metal shell is susceptible to Electrostatic Discharge (ESD). If enough static charge is applied the Display will reset and may show odd characters temporarily. Also, the four front LEDs may indicate incorrectly.

**CORRECTIVE ACTION:** Call AMETEK Power Instruments Customer Services at **800-785-7274** to request an ESD grounding cable # 1089-209 for each UPLC-II that needs to be corrected. This modification is available at no charge and will not affect any applicable warranty.

- Ensure that the protection scheme using the UPLC/UPLC-II at the substation is locked out. \*
- Open the Front Door.
- Power off the UPLC-II by pulling the Power Supply card or other external method if available. \*
- Snap on the clip over the Ethernet shell between the board and front door.
